Bird control at Helsinki-Vantaa Airport in 1978-2007

Olavi Stenman¹, Pertti Savisalo², Juha Joutsen³, Osmo Leppänen³ and Jari Puranen²

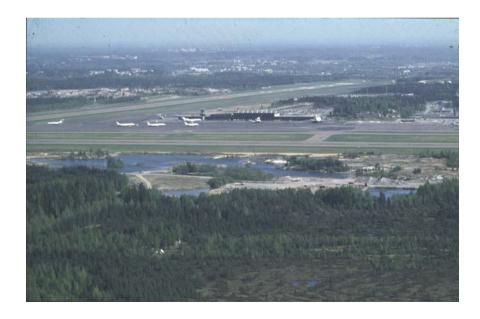
Helsinki-Vantaa Airport in the early 1980s

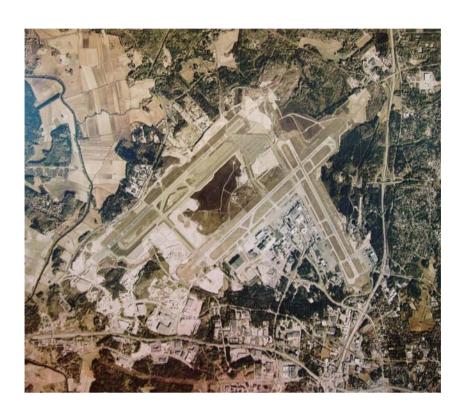
Helsinki-Vantaa Airport in 2007

- -Surface area:
- in total 1700 hectares
- inside the fence 1400 hectares (in 2002, before the 3rd runway, 800 hectares)

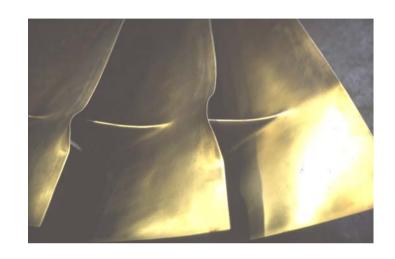
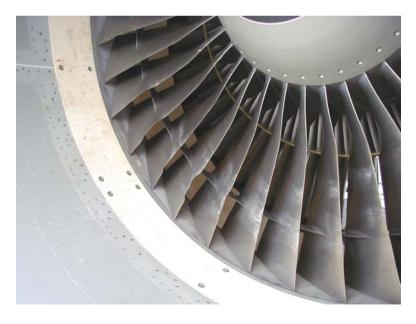
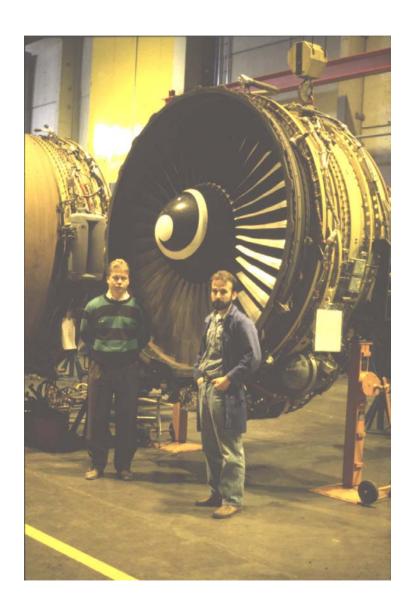
Reparing an engine damaged by gulls

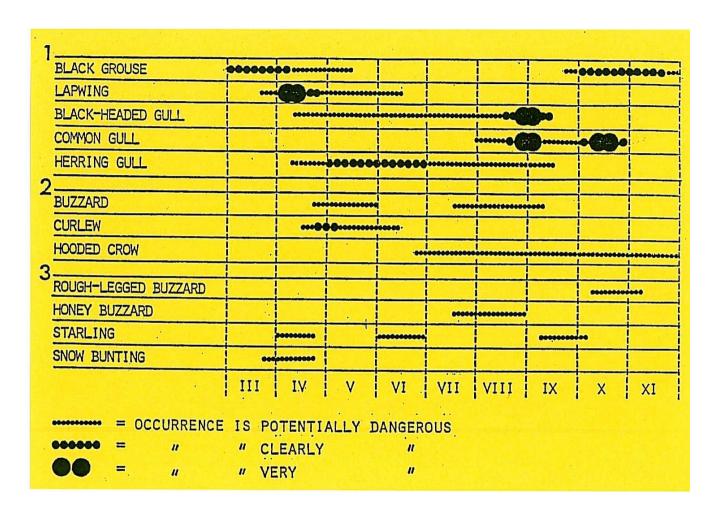
Risk analysis (an example from 1981)

Occurrance and hazardousness of twelve bird species at Helsinki-Vantaa Airport in March-November 1981 on the basis of <u>dispersals and observations by the bird patrol</u>. The bird species have been divided into three hazard categories.

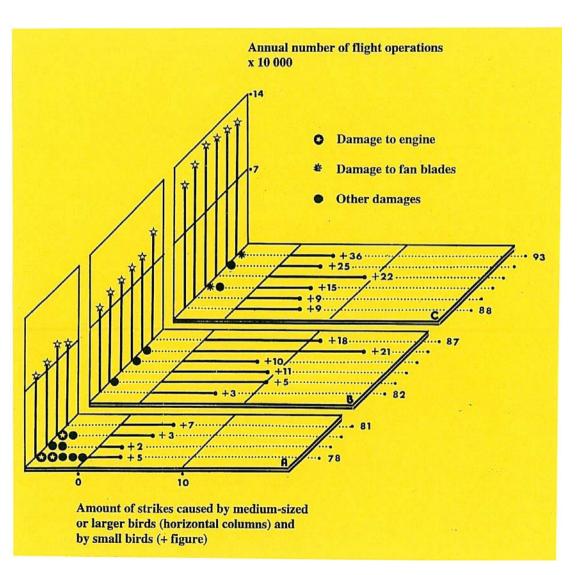
Amount of flight operations and bird strikes at Helsinki-Vantaa Airport in 1978-93

A = a period when pilots were not obliged to give a standardized report on the strikes.

B = the figures include both the strikes reported by the pilots and the cases where the only evidence was a dead bird found on runway.

C = only strikes reported by pilots.

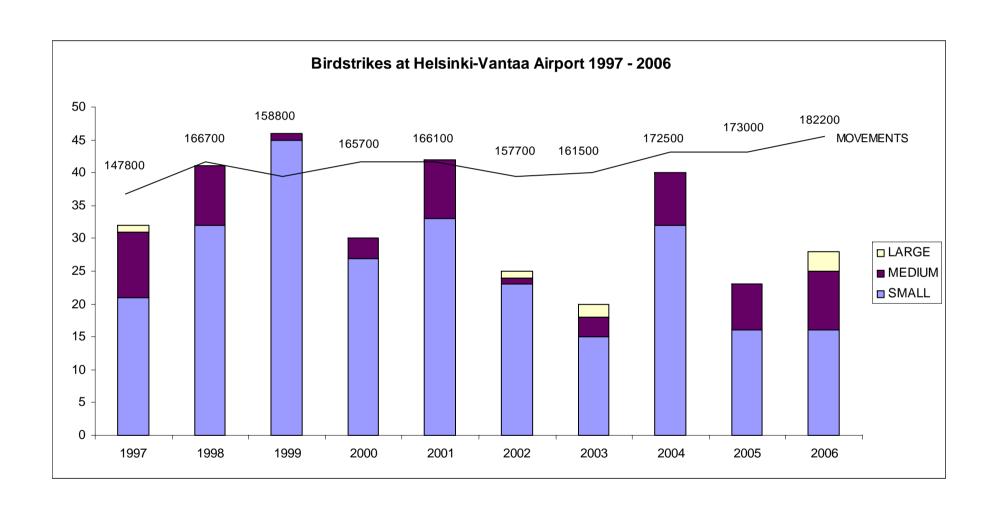
Amount of flight operations and bird strikes at Helsinki-Vantaa Airport in 1997-2006

Bird strike statistics from the years 1978-2006 show that in eight strikes damages were caused to the fan blades or the engine at the airport.
